Home Grown Oak Utilisation

Felling, Extraction, On-site Milling and Grading for a Barn Conversion

East Lydeard Farm, Bishops Lydeard, Taunton

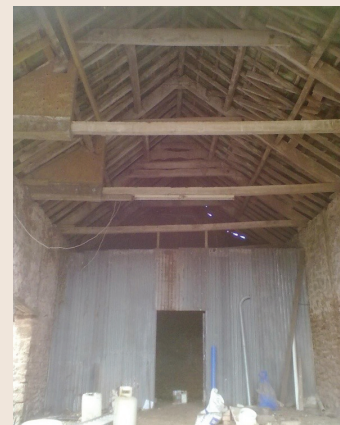
The Barn

Awaiting conversion and refurbishment and the destination for the Oak timber coming from the farm's woodland.

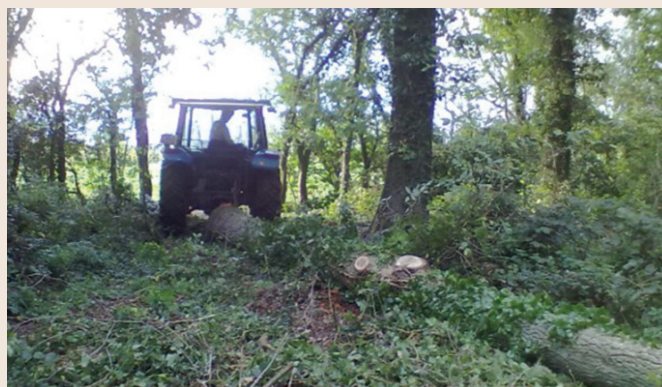
The Felling

The five trees came down safely in the direction as planned with minimal disruption to canopy, sub-canopy, ground flora and fauna.

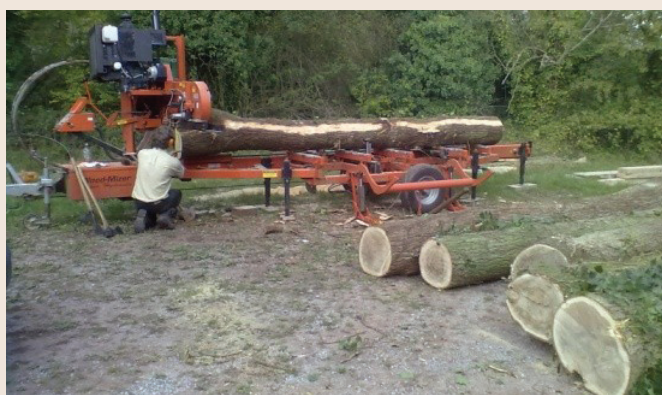
The Milling

With the logs lined up ready for milling, Mark prepared the first one on the mobile saw bench by removing bark along the line of the first cut to protect the blade from grit and stone, thus helping it to stay sharp and cut cleanly....

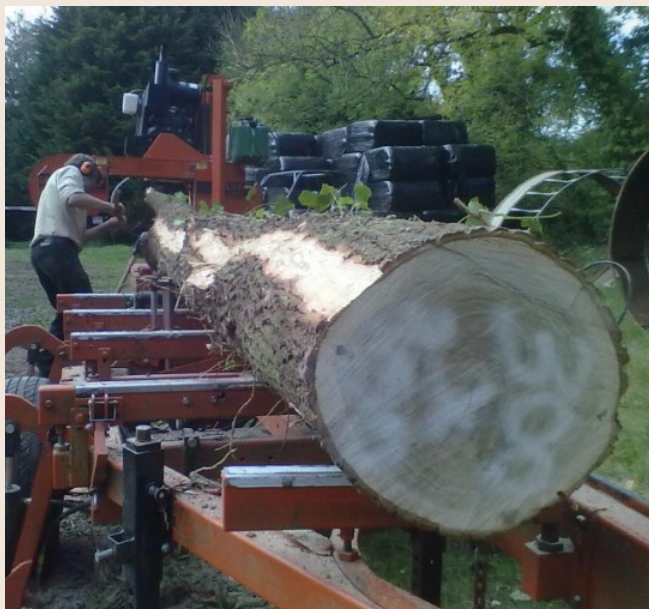
From Round to Square

As the log is turned on the saw bed after each cut a square baulk or cant is formed from which specific section dimensions can then be cut.

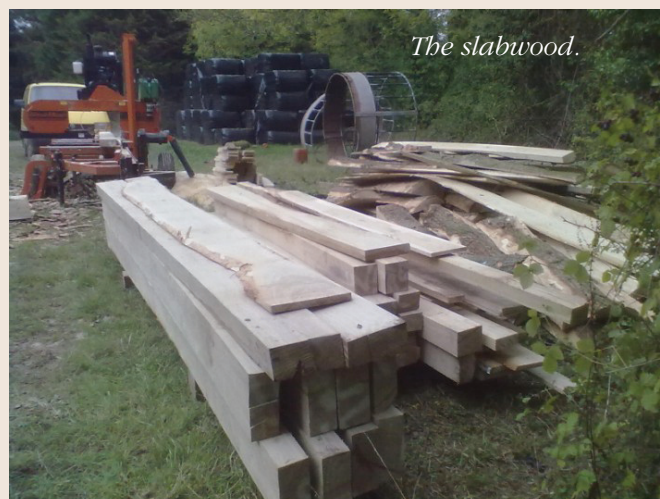
The slabwood.

The finished sections are set to one side ready for stress grading and stacking. Recovery of extra material (over and above material required in the cutting list) was also achieved. But note the amount of slab wood to the rear of the picture. Given more time, a modest amount more of material could be recovered (for example one inch boards with wane edges etc.) from this pile.

Nevertheless, with over three cubic metres of sawn material (2.8m³ of it structural quality) already gained from 7.9 m³ of actual usable roundwood volume an excellent recovery rate was achieved.
